Process Sheet

Customer	: CC-DAR01 Dart Aerospace Ltd.	Drawing Name	: REWORK
Job Number	: 39664		
Estimate Number	: 10804		
P.O. Number	:	Part Number	: D3276042
This Issue	: 03/06/2008 S.O. No. :	Drawing Number	: NCR08-053
Prsht Rev.	: NC	Project Number	:
First Issue	: / / Type : SMALL /MED FAB	Drawing Revision	:
Previous Run	: 39663	Material	:
Written By	:

D3276-041 BAFFLE ASSEMBLY, LH (SHOWN) D3276-042 BAFFLE ASSEMBLY, RH (BEND/JOGGLE OPPOSITE)

From: David Shepherd [dshepherd@dartaero.com]
Sent: June 26, 2008 1:08 PM
To: 'Chris Provencal'
Cc: 'Mike Petsche'
Subject: RE: NCR D3276-041

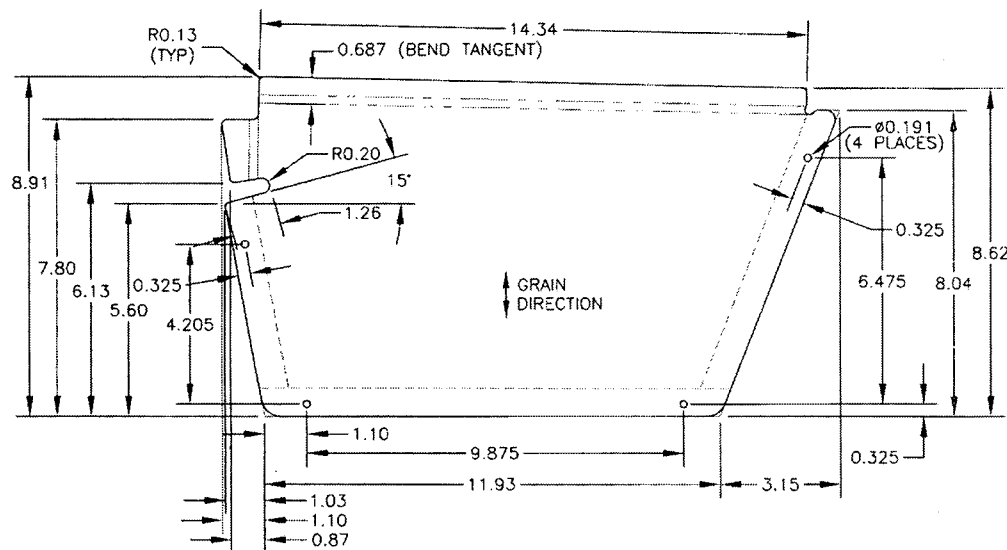
D3276-1 BAFFLE (FLAT PATTERN)

I would be inclined to accept these parts. As you mention, they will not be under any load. Also, if the tab breaks off, I have checked with Harvey, and it will fall into an area of the R44 helicopter where it will not cause any damage.

Qty(22) D3276-041 Baffle Assembly. The joggled tab was bent in the opposite direction from the dwg. They were all reworked to the correct the joggle (re-bent opposite). The grain directions are all at 45 degrees (not vertical per dwg). They were bent while powder coated, so it's impossible to inspect the surface of the aluminum in their current state. One baffle cracked during re-bending.

The part is bolted in, the tab is unlikely to be under any significant stress. However, I'm thinking they should maybe strip the parts (at least locally) to inspect the surface for cracks, especially since one cracked during re-bending. That probably won't be popular....

see attached
LPI not
necessary

Since they were re-bent after powder, could you do an LPI to check for cracks rather than a powder removal. If the metal is cracked, the paint will also be cracked, right? If not, perhaps you could spot check a couple for cracks?
